## TE-DGH/TE-DGHC (CMOS)

**RAM 1500 (2009-2017)**  
**RAM 2500 (2010-2017)**

### Replacement Tailgate Handle with Camera

#### Removal and Installation Instructions

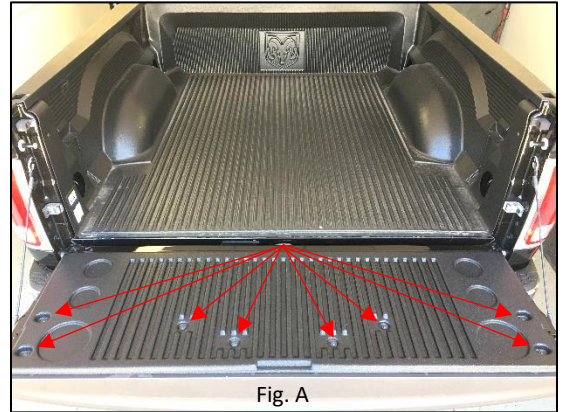
1. Start by lowering the tailgate and remove the (8) T30 torx screws from the bed liner, remove liner (Fig. A), remove access panel (Fig. B), and place aside.
2. Now that you have access to the handle assembly, disconnect harness running to lock actuator and unclip (2) latch rods. (Fig. C)
3. Next, remove (2) 8mm nuts located below latch connectors, then slide latch assembly aside. (Fig. C)
4. Gently remove handle by lifting the handle from the outside and slowly working it out.
5. Now that the handle is out of the tailgate, you will have to swap the locking mechanism out of the old handle to the new one.
6. Start by removing the (2) 8mm screws from locking mechanism, and then remove mechanism from handle. (Fig. D)
7. Now place the locking mechanism in the new handle and secure it with the factory 8mm screws.

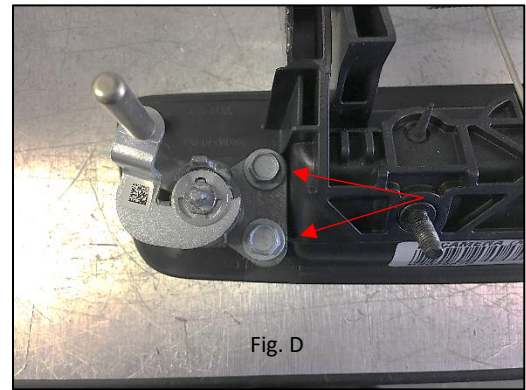
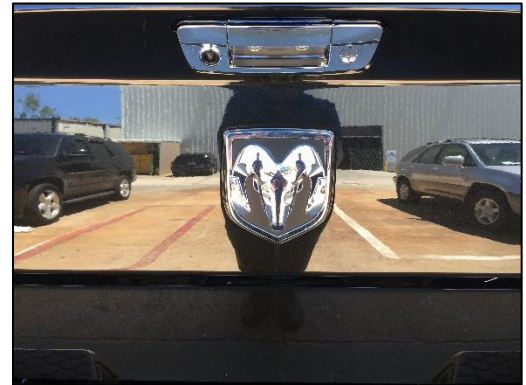
10. Now gently reinsert new tailgate handle and route cable trough tailgate.

11. Realign the handle's post with latch assembly opening mechanism and reattach 8mm nuts to secure handle in tailgate.

12. Reconnect harness to lock actuator and reattach latch rods, then reattach the tailgate's access panel and bed liner cover to complete your install.
